Assessment of Dam Safety of Coal Combustion Surface Impoundments

Indianapolis Power & Light Company

Petersburg Generating Station

Draft Report

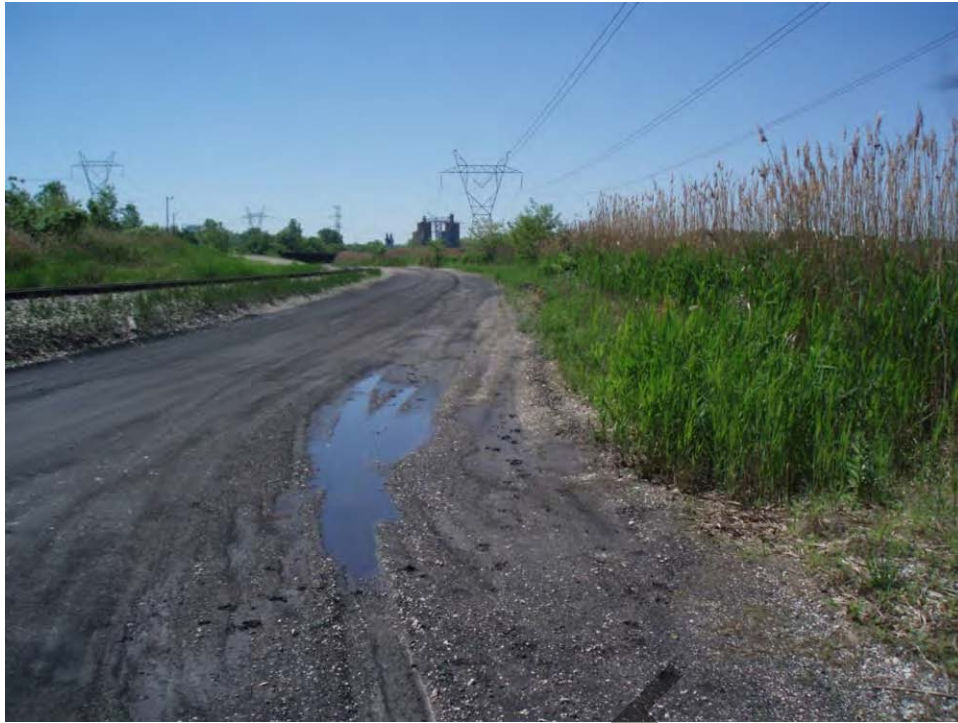
1. Pond A - East embankment crest, looking south.

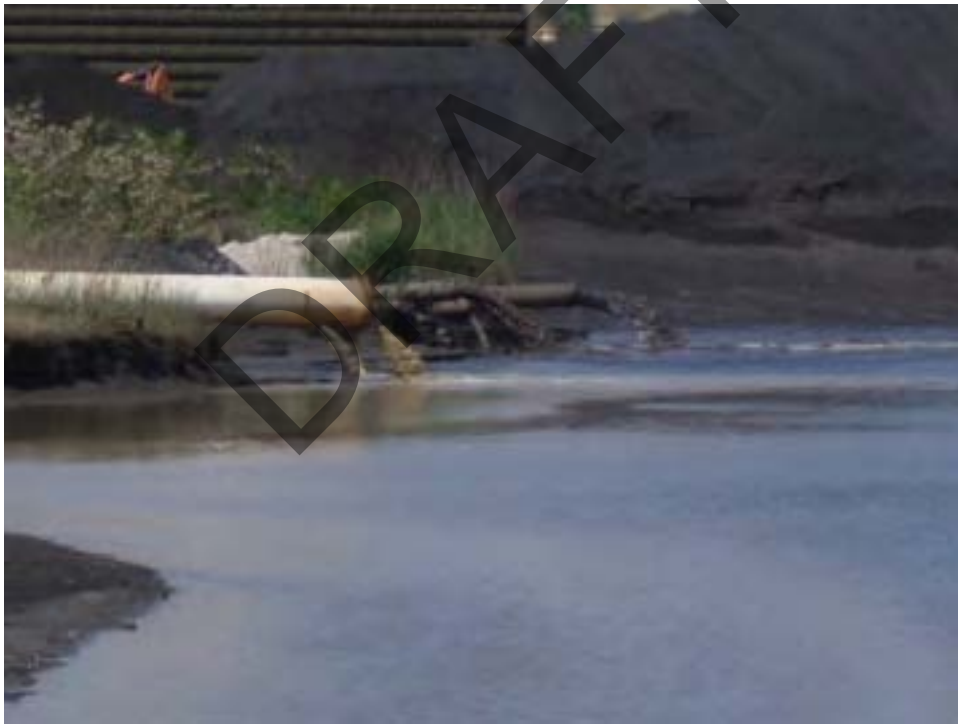
During the site visit four sets of sluice pipes were observed. The CCW sluice pipes on the south embankment appeared to be in fair condition (Photo 8). The two sets of active sluice pipes on the west embankment (Photo 20) and at the west embankment headwall also appeared to be in fair condition (Photo 36). A fourth set of inactive or abandoned pipes appeared to be in poor condition (Photo 30, 33, and 35). The IPL staff did not know the origin or purpose of these pipes. The excavator operator placed ash over the 24-inch-diameter RCP at the fourth set of pipes.

8. Close up of two (2) 36-inch-diameter and five (5) 10-inch-diameter DI sluice pipes.

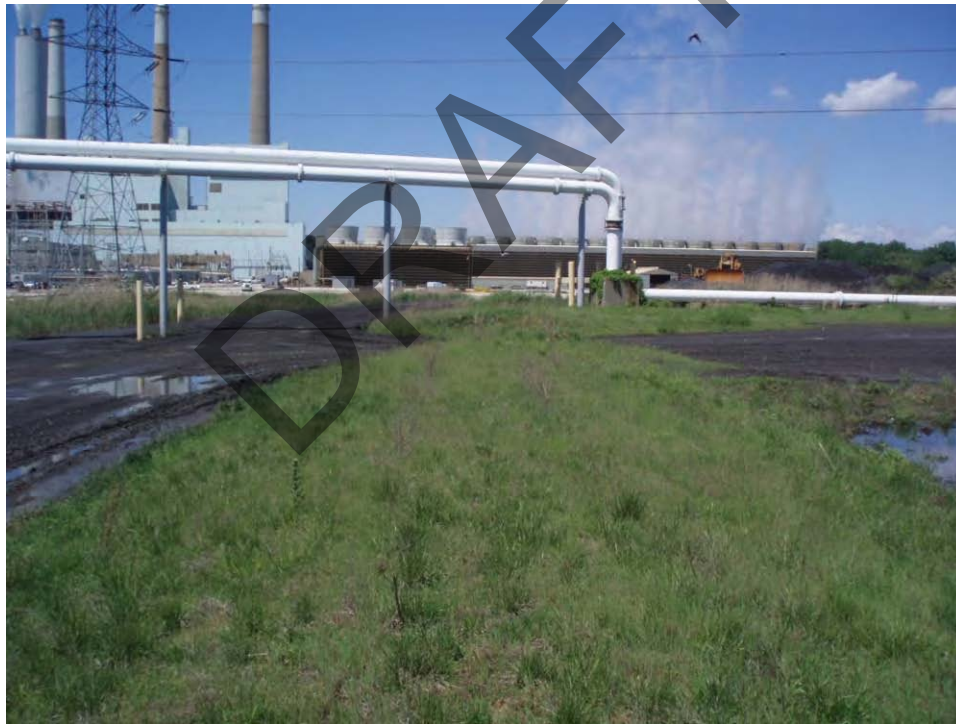
10. Pond A – South embankment crest, looking west. Note access ramp excavated in crest to access the sluice pipes.

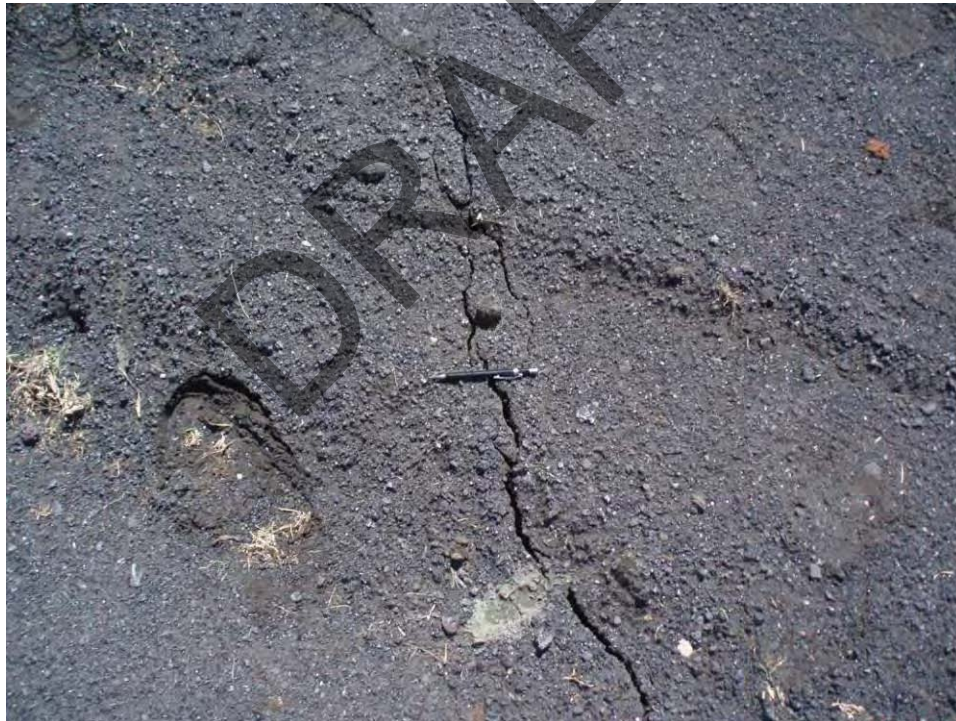
18. Pond A – Surface cracks in recently placed ash material on south embankment crest.

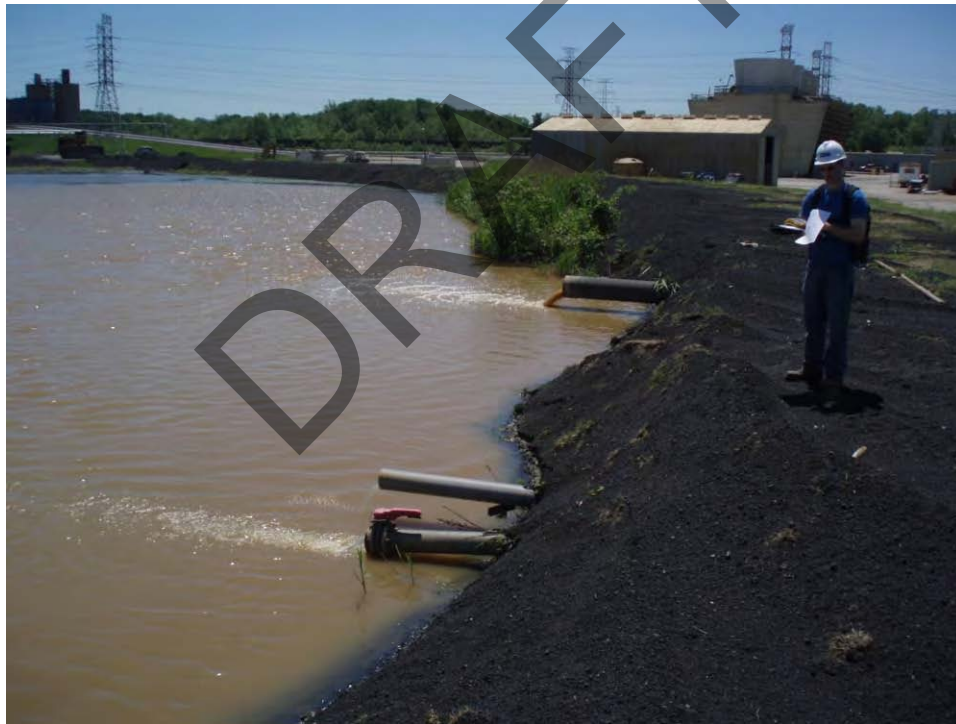
20. Pond A – West embankment interior slope, looking south at one (1) 12-inch-diameter DI pipe and two (2) 8-inch-diameter steel pipes from plant.

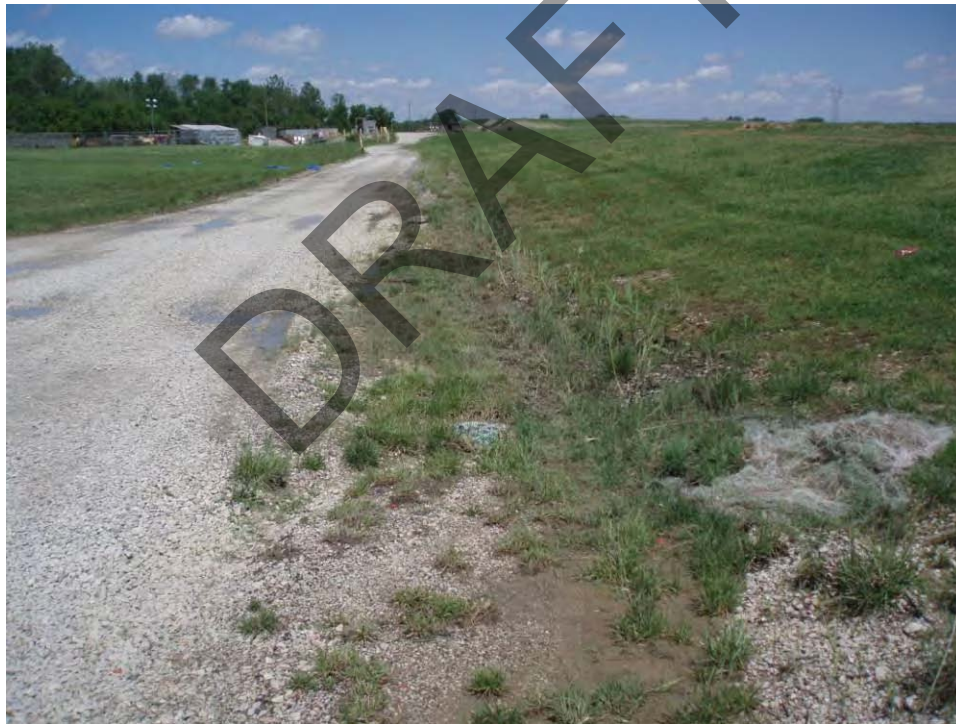
24. Drainage ditch at toe of Pond A west embankment. Note ditch has sparse vegetation.

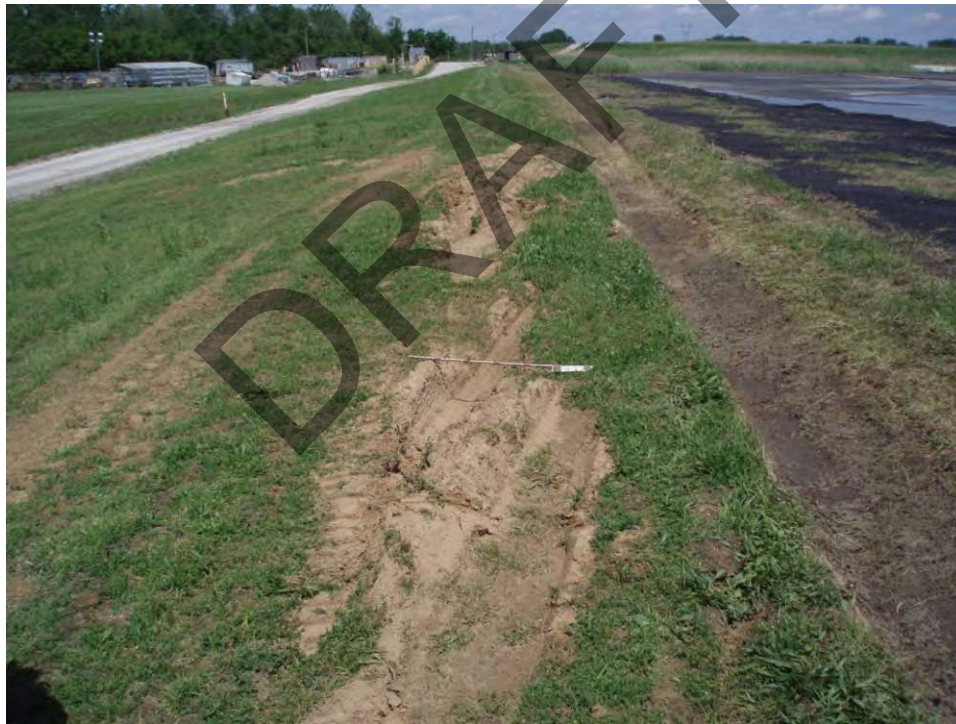
The crest of Pond A generally appeared to be in fair condition (Photos 1, 3, 4, 9, 10, 11, 12, 14, 49, 62, and 64). The crest was approximately 20 feet wide. The crest is surfaced with a compacted gravel access road on the north and east embankment. The crest on the south and west embankment were generally covered with grass approximately 6 to 12 inches tall. The crest around the sluice pipes on the south embankment was covered with ash (Photos 12 and 14). An access ramp excavated into the crest near the sluice pipes on the south embankment was observed (Photo 10 and 12). Track marks from an excavator were observed on the crest of the west embankment (Photos 26, 27, and 29).

26. Pond A – West embankment exterior slope, looking north at large tractor ruts and excavator tracks.

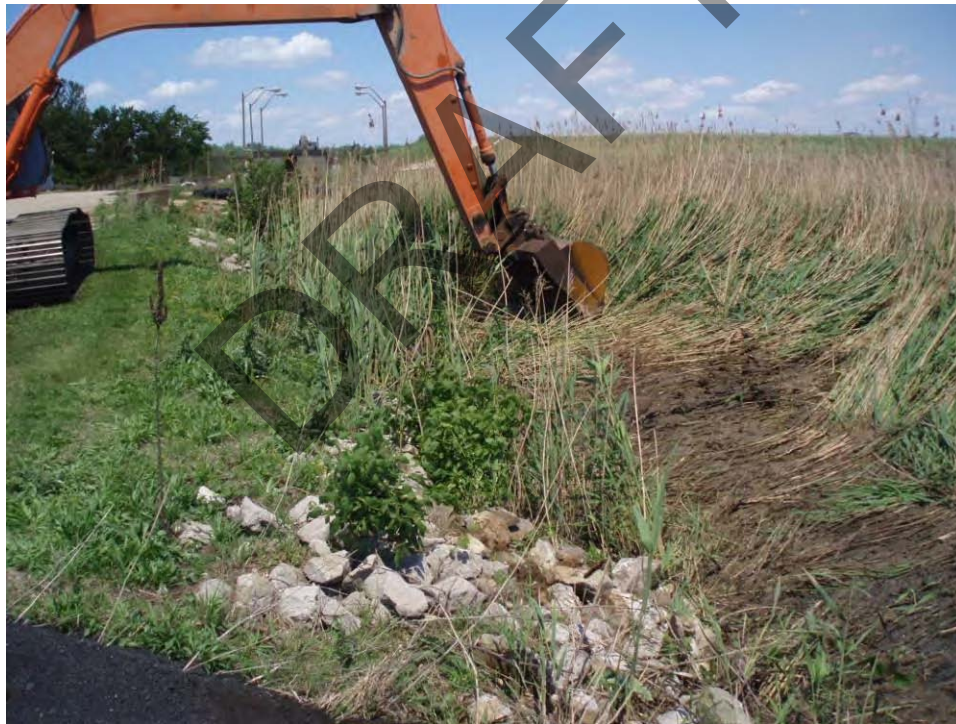
30. Pond A – West embankment interior slope, looking north at excavator flattening vegetation before placing ash material. Note an unknown 24-inch-diameter RC pipe in the embankment was being covered with ash.

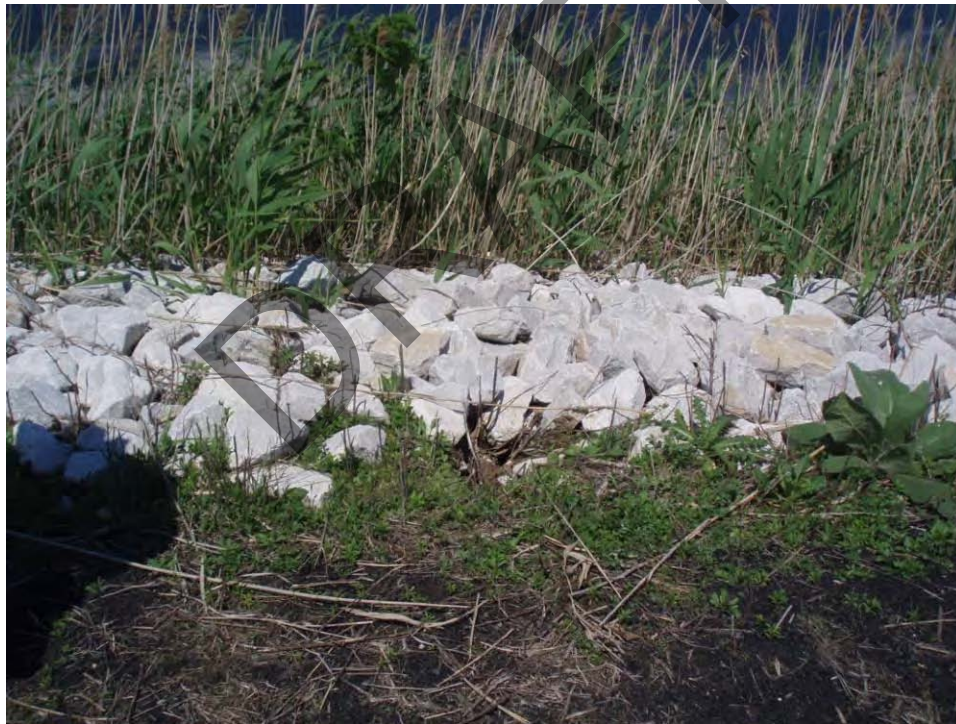
Some surficial erosion under the riprap on the north slope of the divider embankment was observed (Photo 40).

40. Surficial erosion under riprap on north slope of divider embankment between Pond A and Pond A - Discharge.

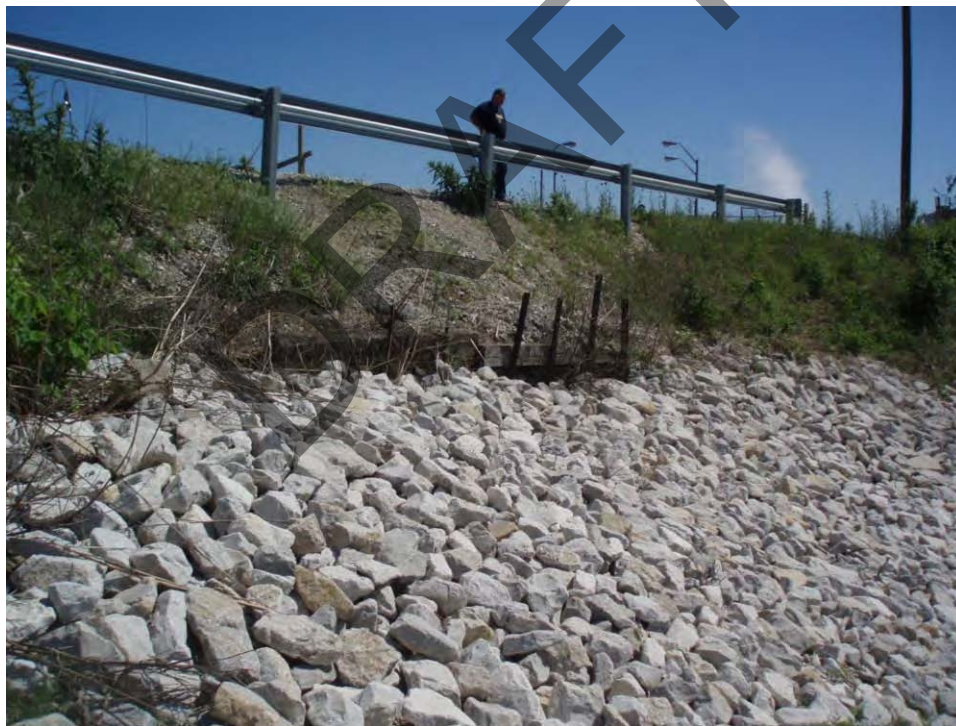
The exterior slopes appear to be in fair condition. The exterior slope on the west embankment was approximately 3H:1V (Photos 70 and 71). The embankment was generally covered with riprap armor to approximately 5 feet below the crest. Some bare spots were observed above the riprap armor. Some metal stakes with 2"x4" lumber were observed above the riprap. The depth of the stakes and lumber, as well as their purpose, is unknown. No erosion or other deficiencies were observed on west embankment during the site visit.

70. Pond A - Discharge, southwest embankment exterior slope looking at steep slope above outfall repaired recently with riprap.

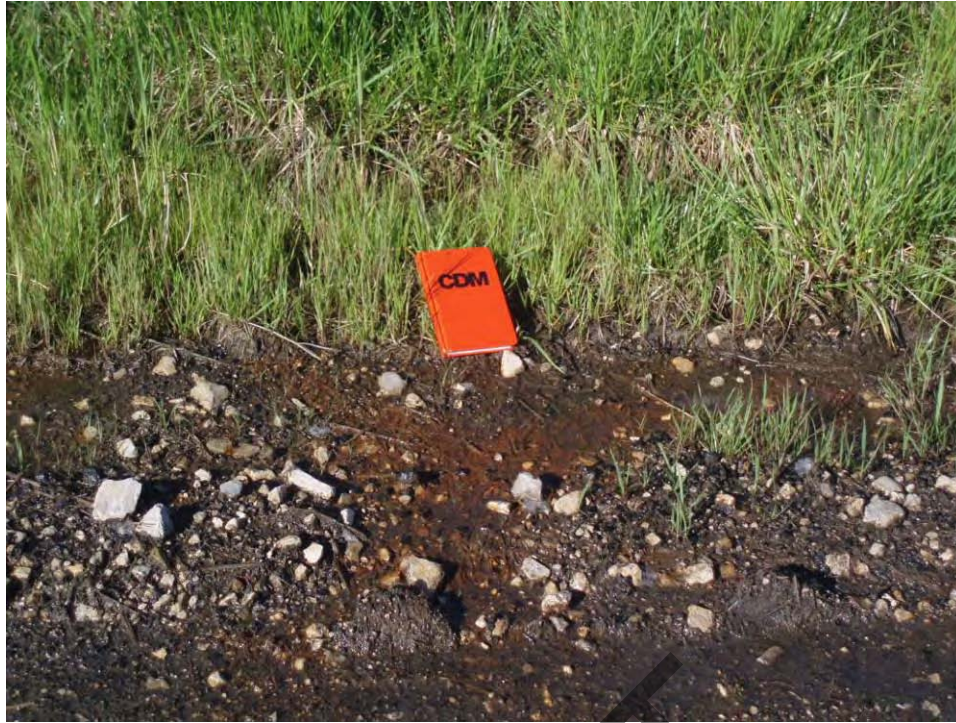
and west embankment (Photos 116, 122, and 125). A white and/or black sheen as well as iron staining was observed in the seepage water.

125. Pond C - North embankment bench, looking at active seepage located at toe of upper exterior slope. Note the iron staining in the water

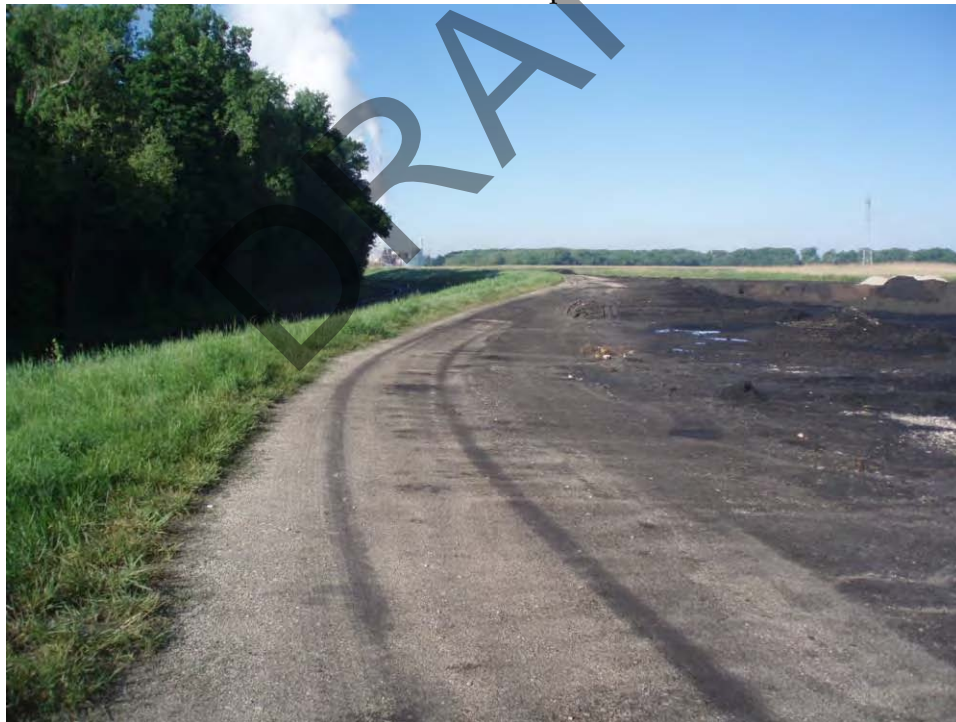
Tractor ruts were observed on the exterior slopes near the crest (Photos 119 and 128) in the very soft, fine grained, stabilized FGD.

128. Pond C -East embankment crest, looking southwest. Note tire rutting was observed in very soft stabilized FGD near the crest.

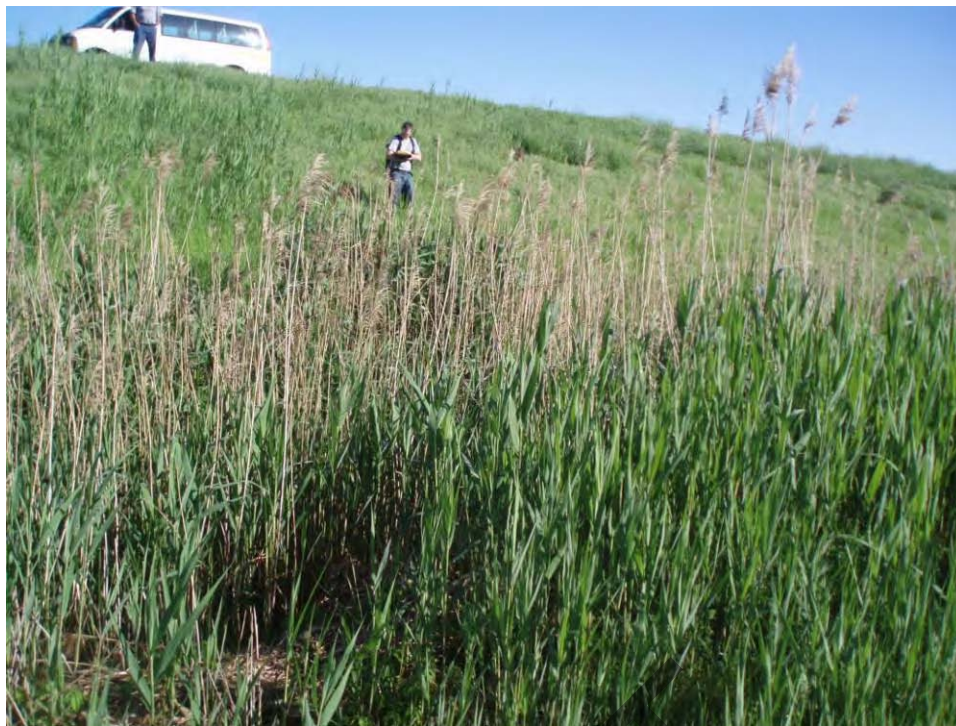
129. Pond C – East embankment exterior slope, looking at area of outlet pipe from outlet structure. Note water was flowing from outlet pipe into drainage ditch.

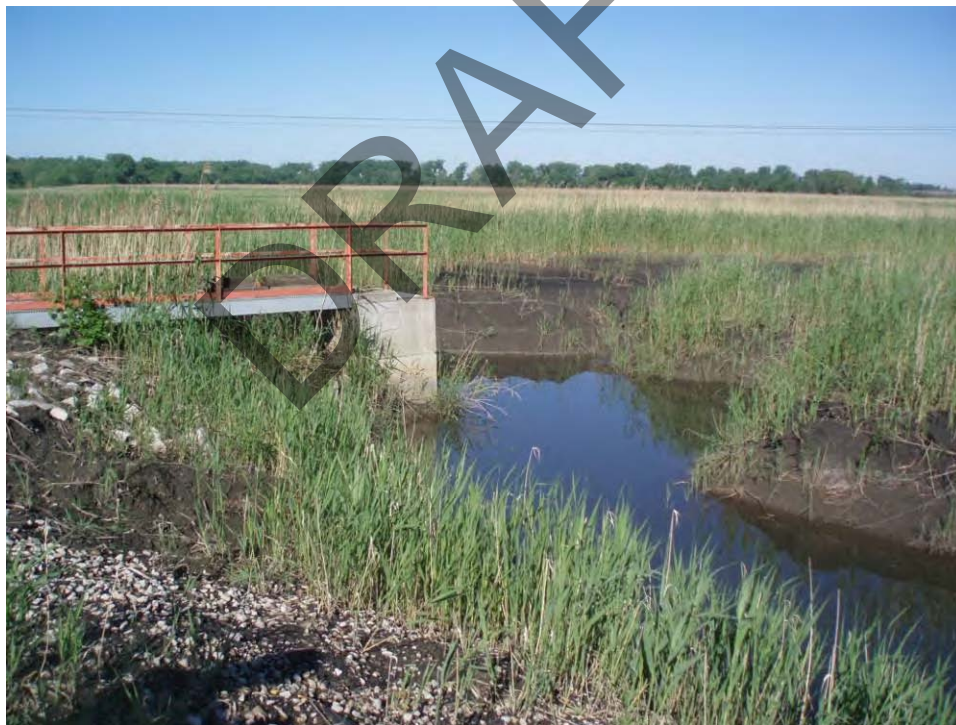
132. Pond C - Outlet structure with stoplogs, looking southwest. Note water level 6.6' below crest at outlet.

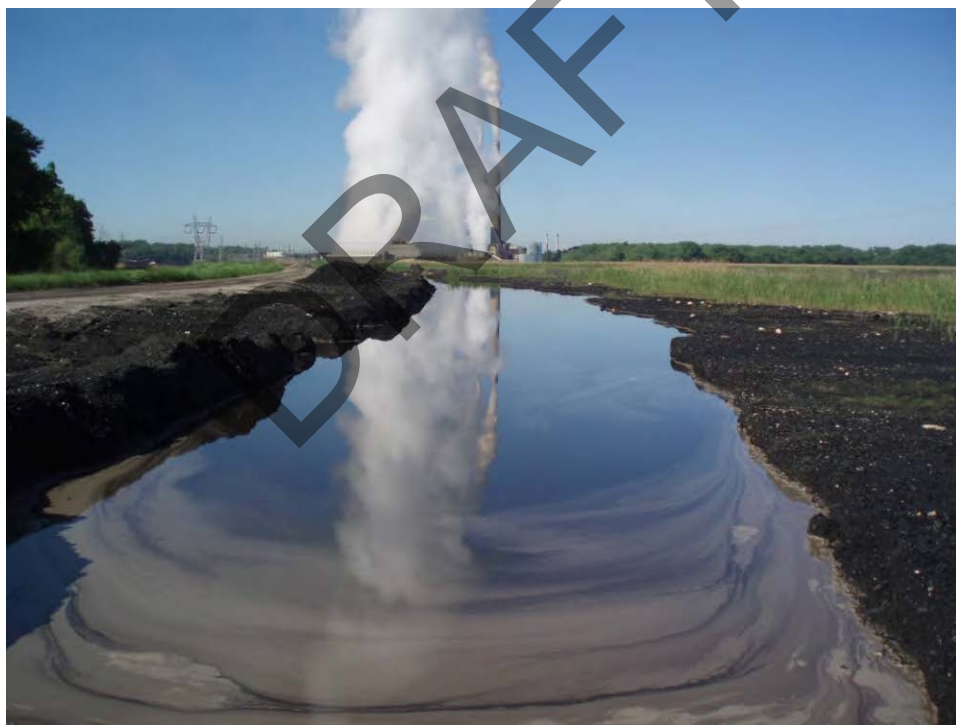
134. Pond C - East embankment interior slope, looking southwest at rim ditch to outlet structure. Note water level 3' below crest.

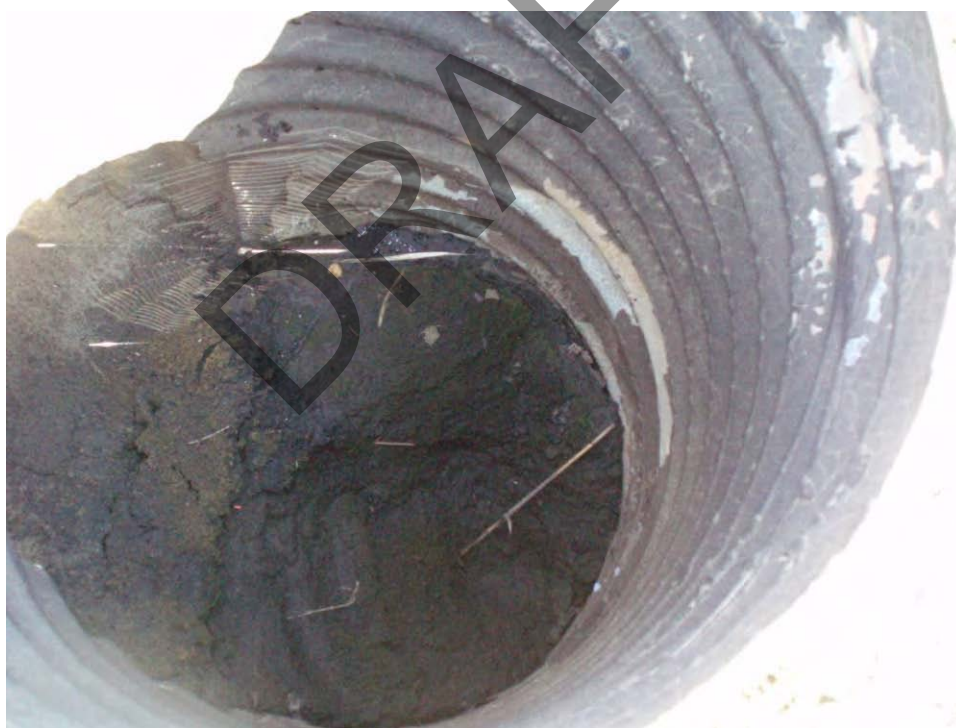
The equalizer pipe in Pond C was in poor condition (Photos 141 and 142). The "T" at the end of the pipe was filled half way with ash.

142. Inside of equalizer pipe at Pond C. Note approximately half of the pipe is filled ash.

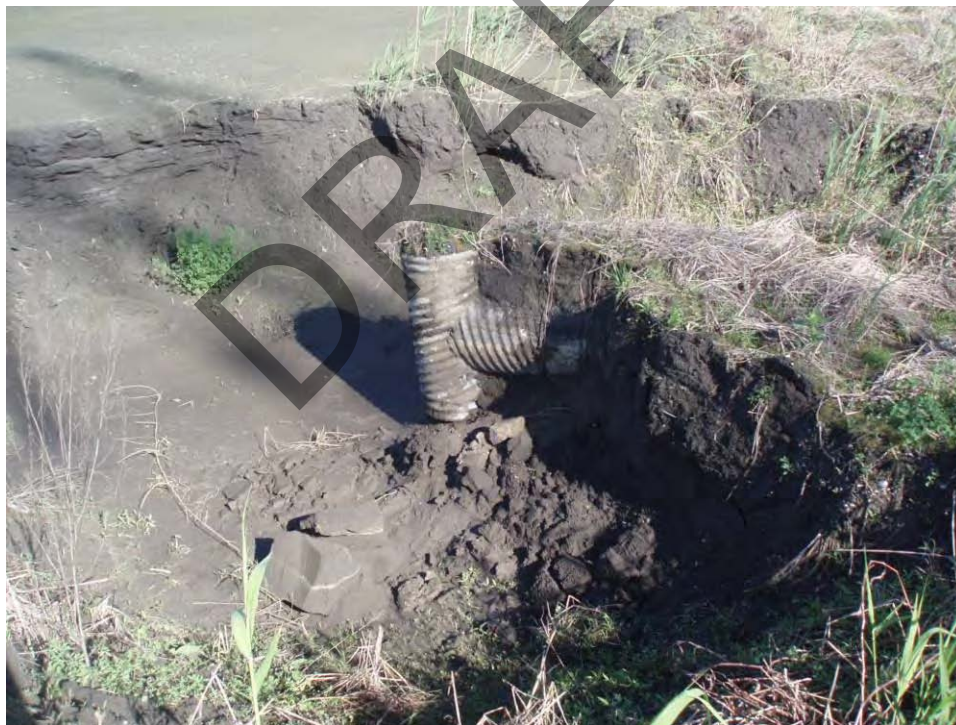
The equalizer pipe in Pond B was in poor condition (Photo 146). The “T” at the end of the pipe was filled to the top with ash.

146. 24-inch-diameter CM equalizer pipe from Pond B to Pond C. Note inlet has a T connection on the end of the pipe and is filled with ash.
